REPORT OF AN ANNOUNCED INSPECTION OF  
THE DISTRICT COURT CUSTODY CENTRE

### REVIEW OF THE PERTH DISTRICT COURT CUSTODY FACILITIES PRIOR TO COMMISSIONING

June 2008

LIN KILPATRICK architect

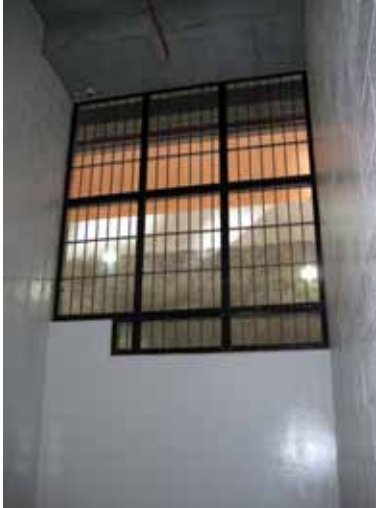
holding courtyard external screen

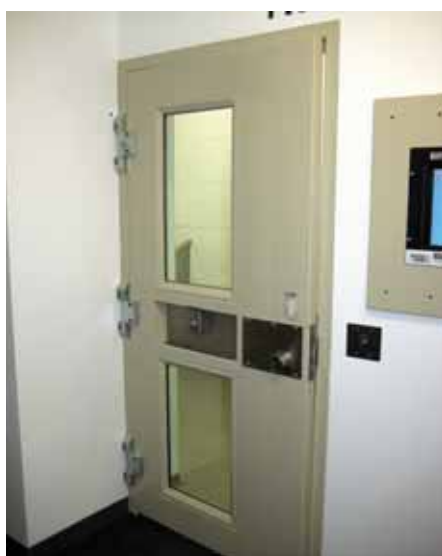
- 4.1.5 There is a significant out of view area within the Holding Rooms 02 at all courtroom levels for custodial staff to view accused persons waiting to attend a hearing or waiting during adjournments. These are likely to be stressful times and both staff and accused persons could benefit by having better direct visual contact with one another.

holding rooms 02 at court room levels

- 1.13 Key Finding 3 relates to the limited observation of the holding rooms at all courtroom levels. This is illustrated in paragraph 4.1.5 of Appendix 1. In discussion, we suggested the use of curved mirrors. The Department in its formal reply has suggested that Master Control has adequate coverage of these areas. There are technical problems with the Master Control System which will be referred to later. However, simply at the level of workload and complexity, it is preferable not to use the Master Control facilities as a primary means of dealing with this problem. G4S would prefer curved unbreakable mirrors.

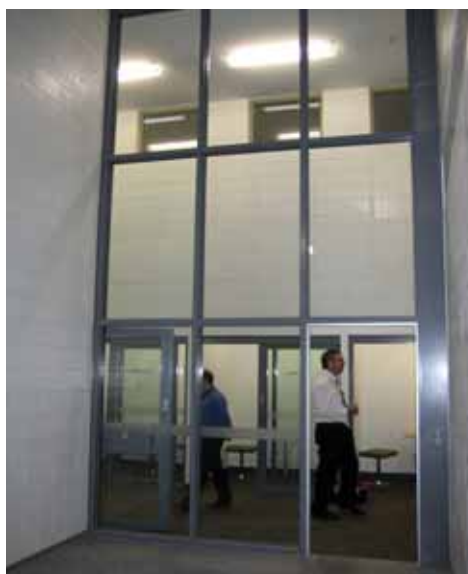
- 4.2.1 The front screens to courtyards 1, 2 and 3, when measured against the strength of the fronts to the main holding rooms, are less secure. If they are to be occupied by persons deemed to be at risk, the screens would need to be strengthened. In any event, these spaces may need to be continuously and directly managed by dedicated staff, as they are remote from the custody halls.

view out from holding courtyards

- 1.15 Key Finding 5 relates to the substandard fitting of the front screens to courtyards 1, 2 and 3. These courtyards have been designed to provide a relatively open “time-out” or assembly areas for persons in custody. They are larger, more airy and higher than the standard holding cells: see the illustration in paragraph 4.2.1 of Appendix 1. However, the screens at the front of each courtyard could probably have been smashed outwards from within by a determined person in custody. Both the Department and the Contractor conceded that this was a fault, and at the time of the Inspector’s own visit this problem had already been addressed by strengthening the fittings. To this point, however, these courtyards have not been utilised as they have not been subjected to the commissioning test which the Department of Corrective Services’ ESG team apply to such matters. G4S have subsequently sought approval to utilise these courtyards for no more than two prisoners per courtyard at a time prior to their transport back to prison.

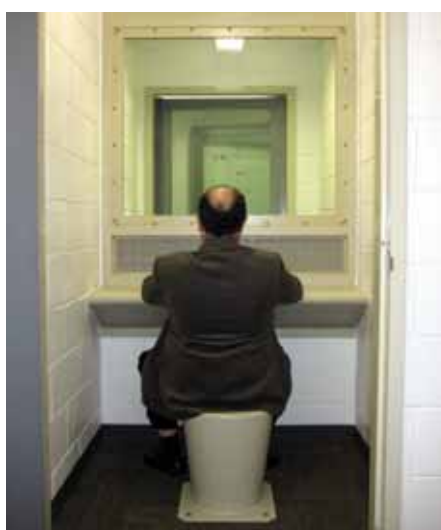
- 4.3.1 The visual connection between a seated visitor and a seated person-in-custody in all of the non-contact visiting rooms may be difficult for persons of small stature due to the relative height of seat vs height of communication screen. This may lead to frustration and therefore add stress within the Custody Centre.

non-contact visiting - secure side

- 1.16 Key Finding 6 relates to the design of the non-contact interview rooms. The fixed pedestal seats are uncomfortably low, particularly for a normal sized or shorter person, with the result that the interviewer and the interviewee may simply be looking over the screen at the top of each other’s heads: see the photograph accompanying paragraph 4.3.1 of Appendix 1. The Department’s response in terms of seeking “at least one seat to be modified” is not entirely satisfactory. The Inspector’s own observation was that virtually all of the seats on the visitor side are too low for comfort.

6.	There is potential uncomfortable visual connection between a seated visitor and a seated person-in-custody in all non-contact visiting rooms due to the relative height of seat vs height of communication screen.	Agreed	Moderate	To be registered with WLJ to allow at least one seat to be modified to increase its height to cater for smaller persons.	Court Security to add to facility defect list.

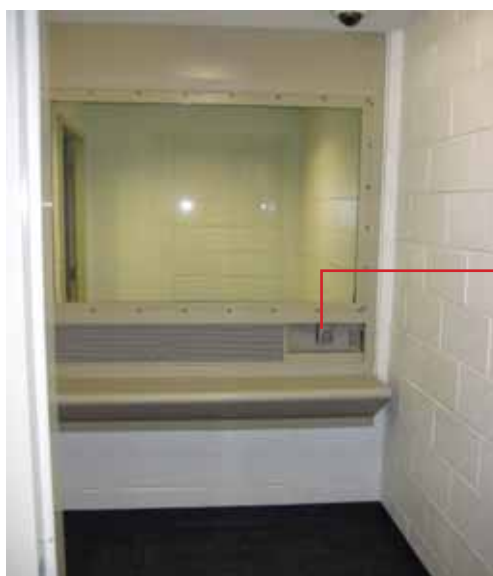
- 4.3.2 The restricted management of secure document transfer in non-contact visiting booths to the one-off secure document transfer hatch provided in the wheelchair accessible non-contact booth - this may lead to time delays and frustration for persons-in-custody and their visitors during busy times needing to exchange documents prior to commencement of their hearing.

wheelchair non-contact visiting - secure side

- 1.17 Key Finding 7 relates to the secure document hatch. There is only one such hatch, which is used to enable documents to be passed between lawyers and clients, and this is situated within the non-contact area set aside for disabled persons in custody. Consequently, if that cubicle is in use there would be disruption or delay involved in passing the documents. The Department does not intend to modify this. The observation of G4S to date is that the document hatch is very seldom utilised so that the problem can be addressed as required by one-off processes involving the staff.

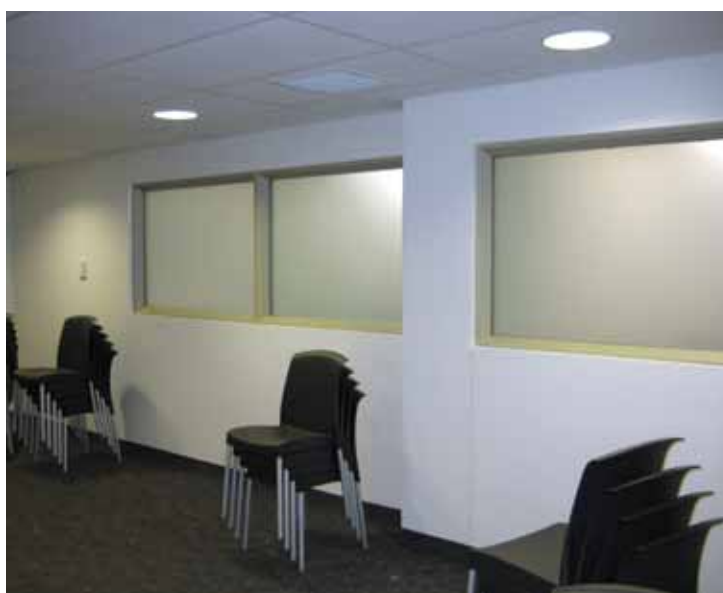
- 4.4.1 The opaque film which has been added to the viewing windows between the public accessible bail waiting room and the secure bail waiting rooms to prevent sight lines into the custody centre continue to provide a sense of movement which could generate anxiety between bailees and separated families.

public accessible bail waiting room

- 1.18 Key Finding 8 relates to the opaque film across the glazed screens between the secure bail holding rooms and the non-secure publicly accessible, bail waiting room: see the photo and discussion in paragraph 4.4.1 of Appendix 1. The perceived problem was that when a person who has been in the publicly accessible part of the bail holding room has to be moved to the secure area, his or her family or supporters may still be aware of the movements and shadow of that person through the opaque glass. That being so, there is a risk that the opaque film may be scratched clear, and this indeed has already started to happen. Obviously, a clear screen is not desirable as it would tend to add to attempted communication efforts, possible distress and even conceivably occasional disorder. The opaque film needs to be replaced by a scratch proof substance or a solid cover of some kind. This has been accepted by the Department and the Contractor.

8.	There is opaque film across the glazed screens between the secure bail holding rooms and the non-secure (public accessible) bail waiting room.	Agreed	Moderate	This was the remedy applied to stop members of the public viewing persons in custody walking past the doors to the bail holding areas. This remedy allows the officers to see in clearly to monitor the occupants of the bail	Court Security to add to facility defect list.

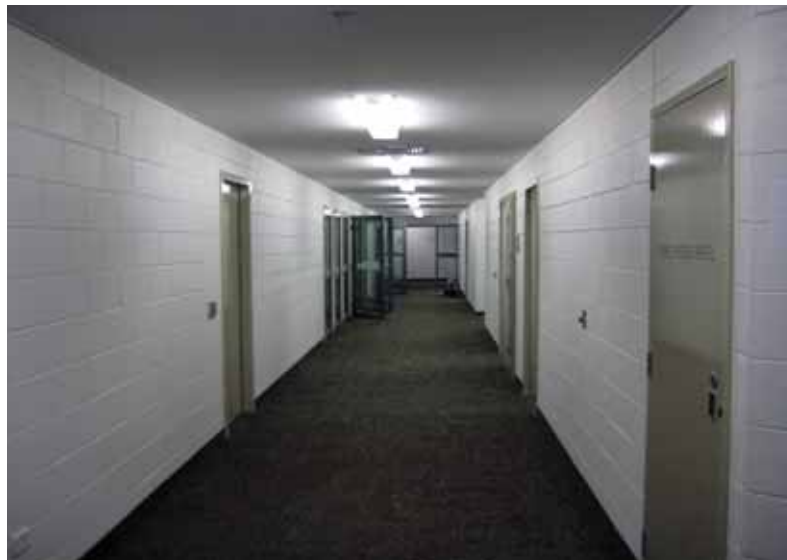
- 4.5.1 Potential conflict of movement may occur between activity in each wing forming the central corridor within the secure custody zone.

wing A of central movement corridor

- 1.19 Key Finding 9 relates to movement patterns within the custody area. The identified problem is best understood by reference to the diagram in paragraph 3.2 of Appendix 1. The area described as “central movement” includes a space (identified by the number 2) where persons in custody may be out of sight of the control room or officers physically present in the main central movement area. The suggestion is that an additional door should be fitted so as to break the central movement area into two segments.

- 1.20 Both the Department and the Contractor agreed that security and safe-handling would be enhanced by taking this course and the Contractor will press for this to be done. The Department’s official position, however, is that it believes the potential problem can be adequately addressed by enhanced or changed processes. G4S does not agree and suggests that one fewer airlock and one more door would assist the security and the operator convenience of the area.

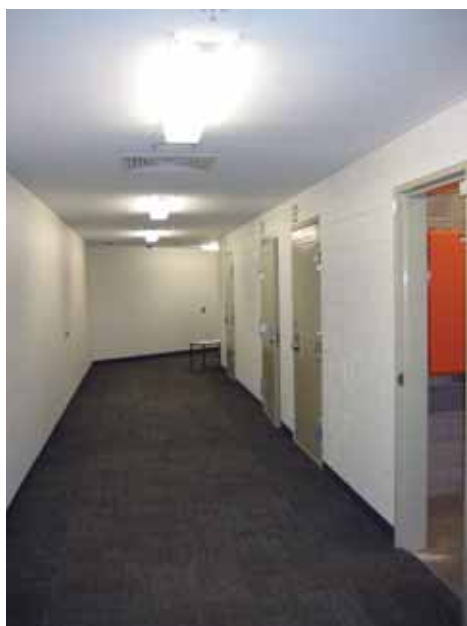
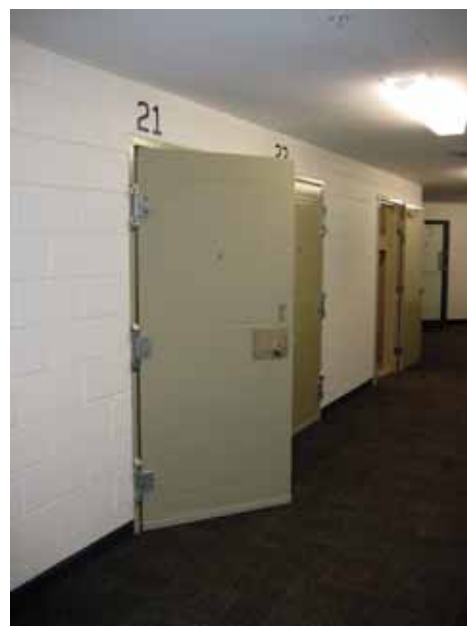
- 4.5.2 The rear doors to holding spaces in holding zone 2 could become the easy default to regular access into and out of the holding zone away from the staff observation base.

corridor link to Magistrates Courts - rear doors to holding rooms

- 1.22 Key Finding 11 is concerned that movement patterns may develop for Contractor convenience along the area identified as Area 4 in the security format diagram found in paragraph 3.2 of Appendix 1. Both the Department and the Contractor concede the theoretical possibility of this. However, the Contractor has not opened any of the doors from Holding Area 5A in paragraph 3.2 to Area 4 and does not intend to do so. Indeed, G4S goes as far as to say that “any use of the rear doors requires senior operational authority.”

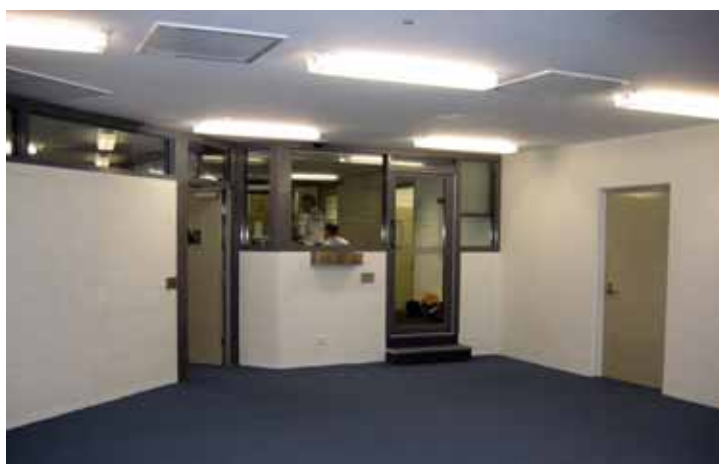
- 4.6.1 Potential sight lines available to persons-in-custody between holding rooms 1 and 21 across the staff observation base.

view towards staff observation base from custody hall 2

- 1.21 Key Finding 10 relates to a line of sight between Holding Area 1 and Holding Area 2. This point is best understood by reference to the schematic diagram in paragraph 3.3 of Appendix 1. The line of sight goes from the cells on the right hand edge of Holding Area 1 through the control room to the cells on the left hand top edge of Holding Area 2. It was anticipated that this could provide opportunity for disorderly conduct, and indeed since the opening of the area this has occurred. A female prisoner in the Holding Area 2 stripped off various layers of clothing and was thus visible to the prisoners in Holding Area 1.

The matter is simply addressed by installation of a curtain on the Holding Area 2 side of the control room, and this has been done.

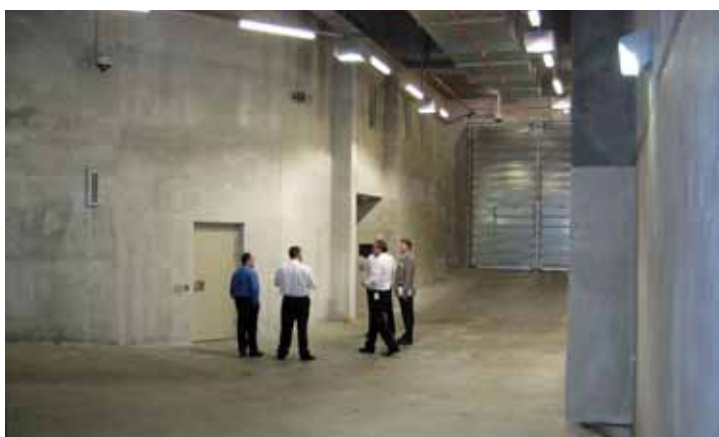
- 4.8.1 There are no staff duress alarms in the vehicle sally port.

vehicle sally port

- 1.24 Key Finding 13 refers to the absence of duress alarms in the vehicle sally port. This issue is conceded and will be addressed.
- 1.25 Key Finding 14 refers to the possible contraband and security risk that could arise in the use of the contact interview/visits area: see Area 4 in Overlay 5 of paragraph 3.2 of Appendix 1. To this point the contact interview/visits area has not been utilised at all. The Department and the Contractor state that the risk, if and when the area is eventually utilised, will be managed by strip searching persons in custody at the end of any such contact visit and searching the visitor as he or she enters the visits area. This process would then be monitored and assessed.

No.	Summary of Key Findings	Level of Acceptance	Risk Rating	Response Summary	Action Plan
13.	There are no wall mounted duress alarms in the vehicle sally port. Elsewhere, there appears to be an inconsistency of height in their location.	Agreed	Moderate	Standard design brief to specify optimum position.	Court Security to add to facility defect list.
14.	There appears to be concern about security risk associated with the use of the contact visiting facilities ie. introduction of contraband by visitors.	Agreed	Moderate	This is mitigated through policies which require all persons in custody attending this area to be strip searched at end of visit, with visitor searched prior to entry.	Managed through Tier 2 monitoring
